BLIP Raster System Project Closeout Review

Project Closeout Review
August 22, 2016

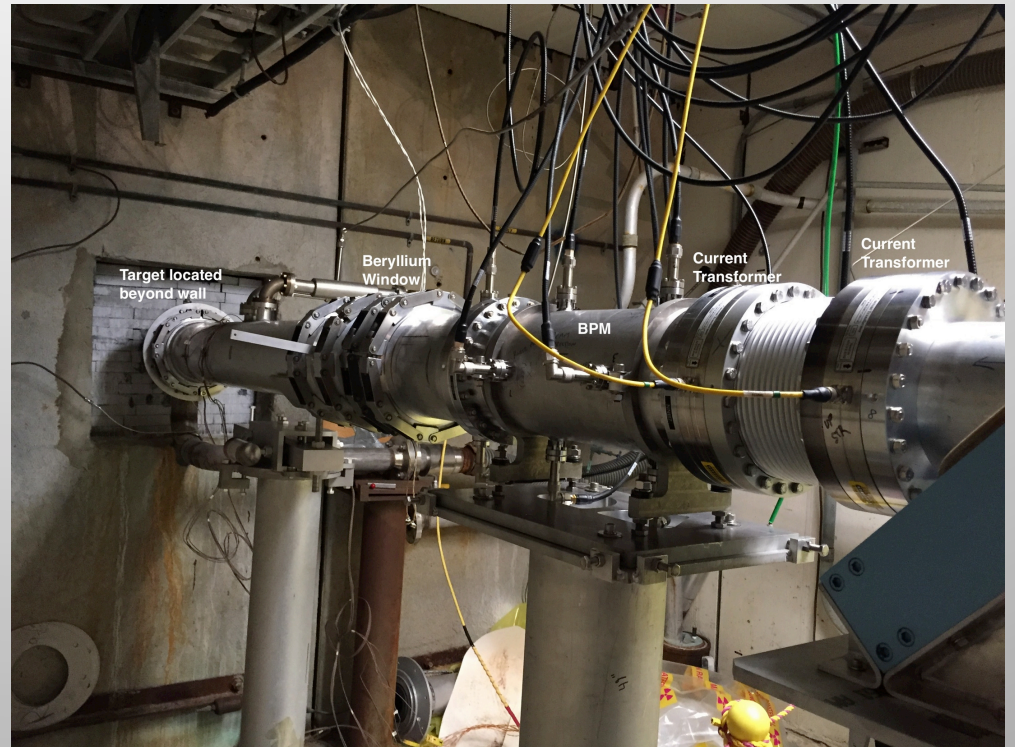
Downstream section of beam-line
(beam direction is to the left)

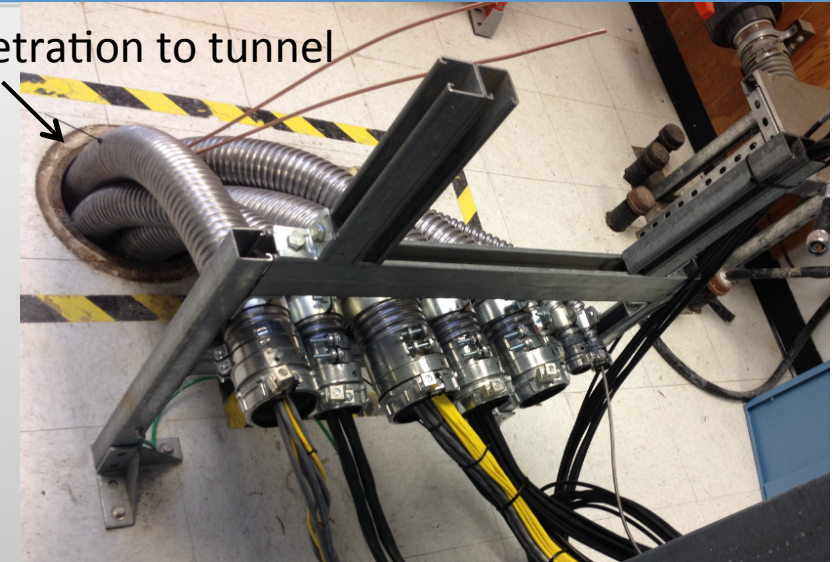
Penetration to tunnel

- Elevated levels of Oxygen-15 were detected in the BLIP control room soon after beam operations began. Although these levels were only 1% of the allowable limit, this was about 4x levels of previous years.
 - Cause was found to be air leaks from the beam tunnel through the cable penetration. This penetration was sealed for many years until being open for installation of raster system cabling.
 - Air gaps in penetration were sealed with spray foam insulation and conduits were sealed with duct sealer.
 - Oxygen-15 levels are now similar to past years

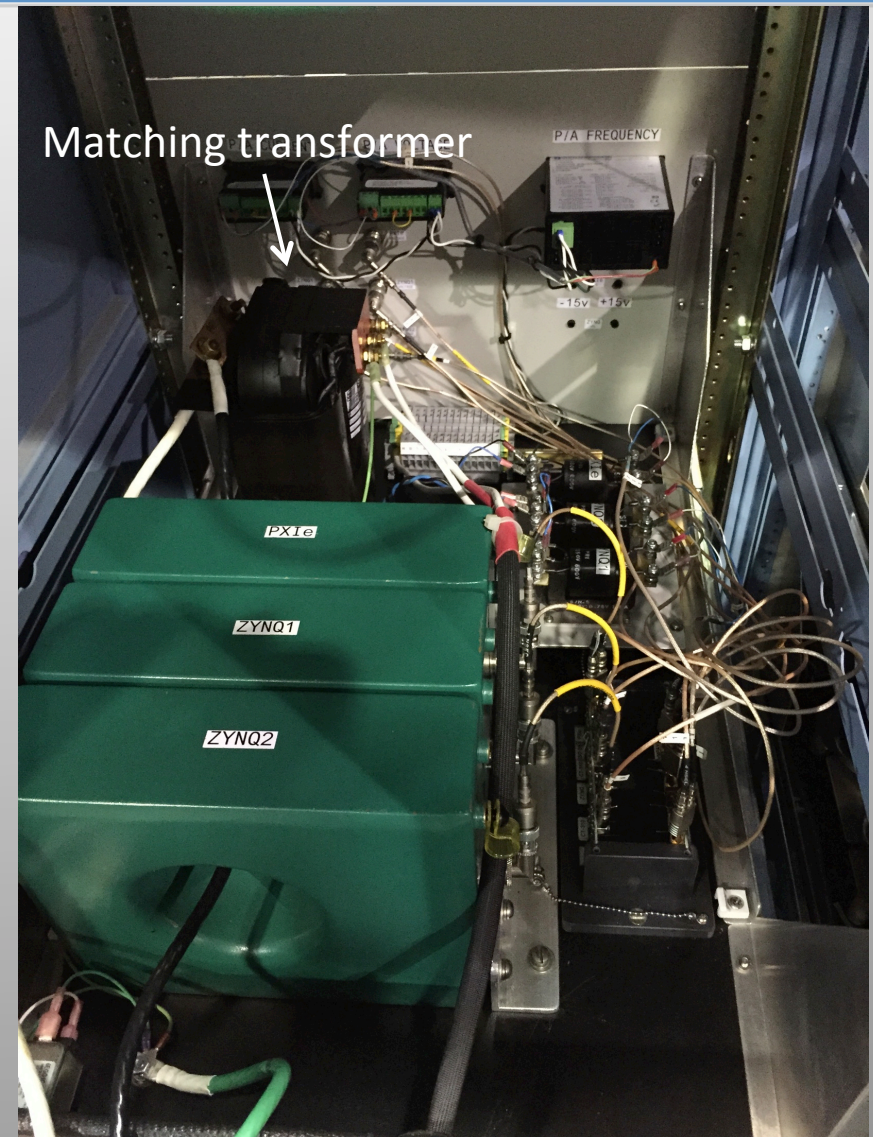
Power supplies could not operate at full magnet design current

- After early testing of power supply and magnet system, learned that the magnet could not be operated at the full design current. The power supply current at 5kHz was limited to about 120 amps peak for continuous operation, significantly lower than the 318 amps design peak current.
 - The magnet losses were higher than anticipated, and thus caused limitations for the power amplifier output.
 - New matching transformers were purchased and installed to provide more optimal matching between the power amplifier output and the magnet resonant circuit. This ultimately allowed the system to be operated at the full 318 amp peak design current.
 - A magnet loss calculation error was found that fully explains the issue. Losses in the magnet coils were actually about 2x the originally calculated value.

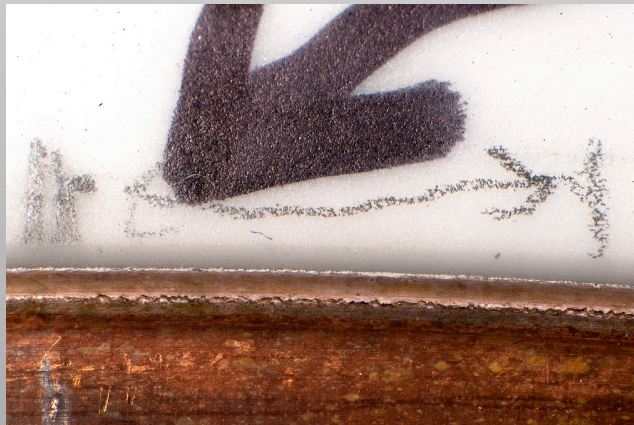
- A vacuum leak was detected in the raster magnet ceramic beam tube transition section when final leak check was performed just prior to installation.
 - This required a total rebuild of the magnet using one of the spare ceramic beam tubes.
 - Exact cause is unconfirmed but is expected to be a defect in the transition brazing.
 - Other possible causes are vibration or heat.

Zoom-in of failed section.
Note cracks in brazing.

- To be conservative:
 - Maximum operational peak current will be limited to 260 Amps instead of the 318 Amp design current.
 - Water cooling was added to transition section.
 - Magnet current will be ramped up to heat components slowly and evenly.

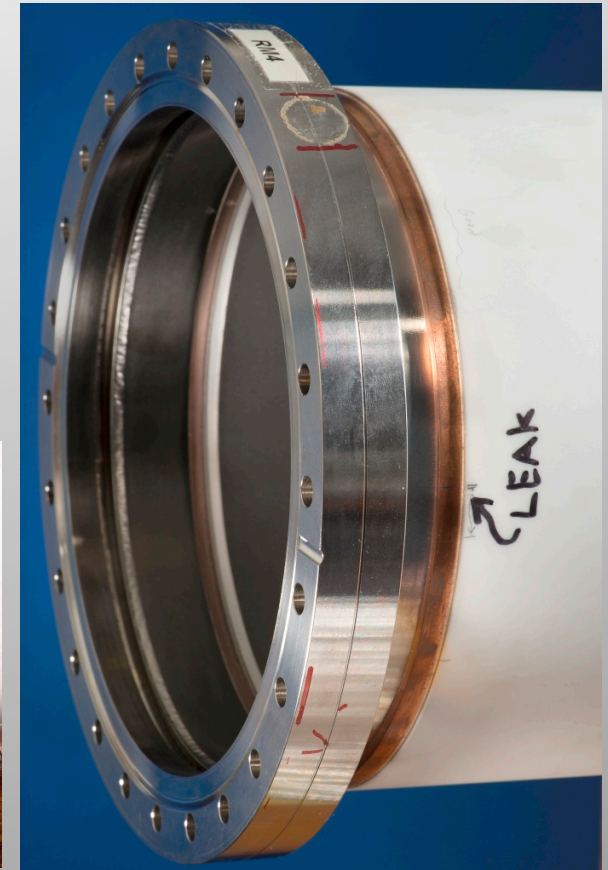
Failed ceramic beam tube.
Leak detected at transition
from ceramic to copper to
stainless steel flange.
